# « JUST THE FACTS »

## Diesel Fuel Injection Pumps - Remanufactured

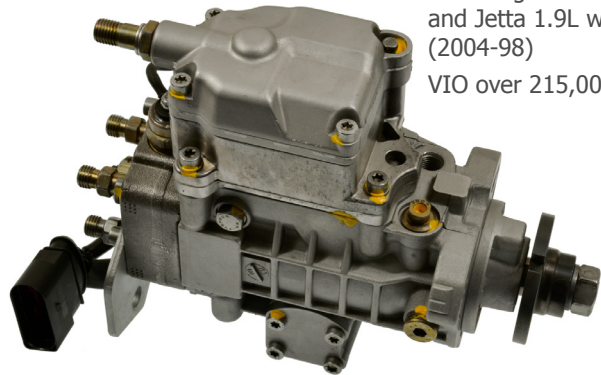
### 35549

Volkswagen Beetle, Golf, and Jetta 1.9L w/ AT (2004-98)  
VIO over 215,000

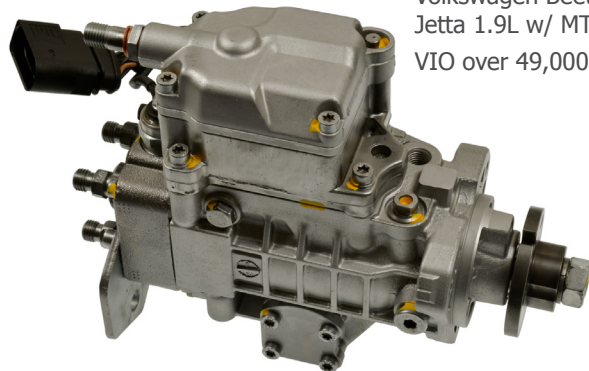
### 35550

Volkswagen Beetle, Golf, and Jetta 1.9L w/ MT (2004-98)  
VIO over 49,000

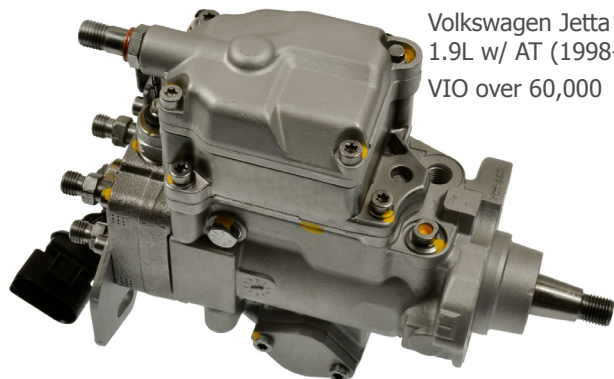
### 35551

Volkswagen Jetta and Passat 1.9L w/ AT (1998-96)  
VIO over 60,000
